Warrnambool Christ Church

The place

Heritage significance

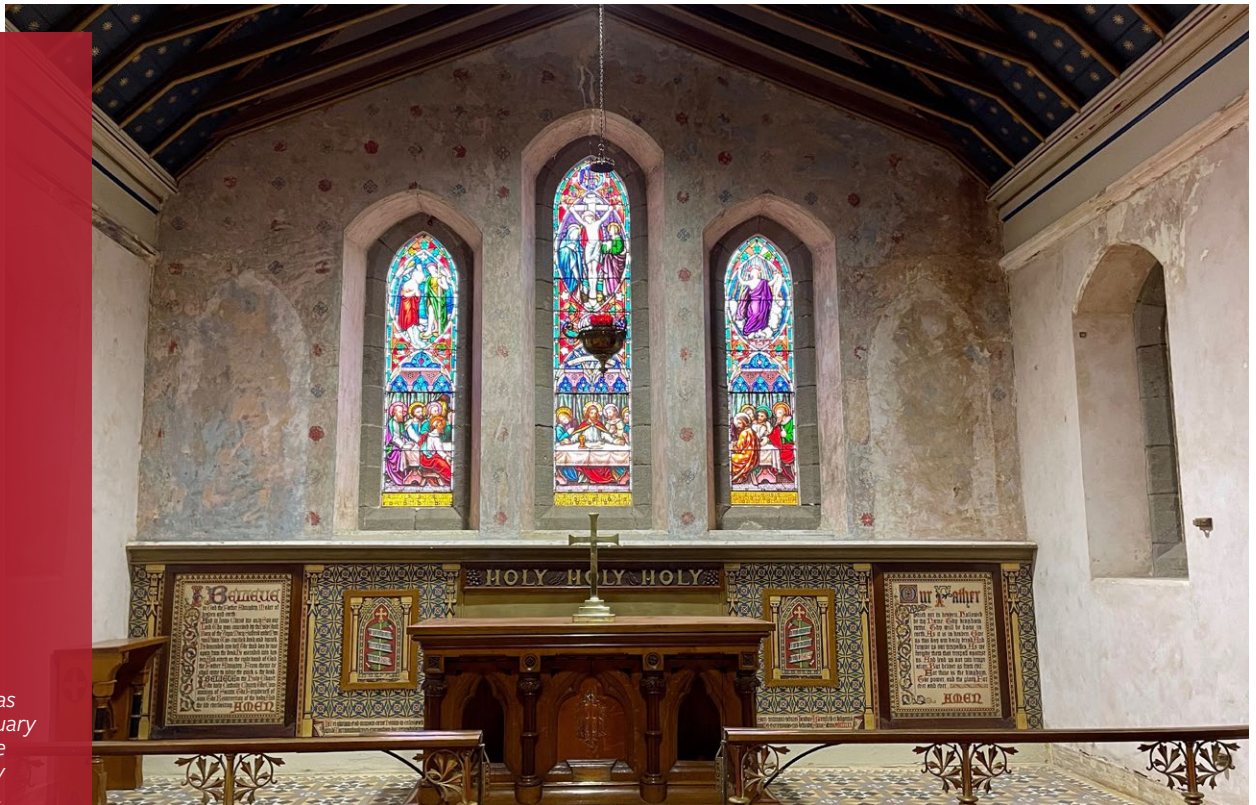
Interior paint was removed in January 2022 to enhance the breathability of the materials.

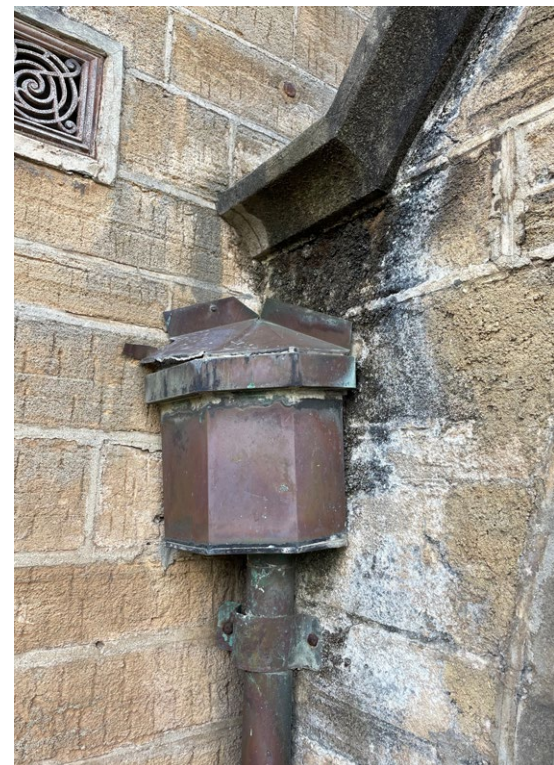
Salt deposition on limestone from gutter and downpipe overflow.

Lack of capacity in gutters and downpipes could result in overflowing gutters, allowing excess water to flow back into the building and causing water damage to the building fabric, interior finishes and fit-out.

- o ensuring that gutters, downpipes and drains are cleaned as part of regular maintenance, and replaced if their condition risks further decay of buildings

- o inspecting roofs annually to check for failing or dislodged fixings, flashings and capping, and effecting repairs promptly
- o reviewing drainage and maintaining air drains around walls to minimise moisture against walls and reduce damp
- o enlarging the gutter and downpipes to enhance the building's drainage capacity (using the same profile will have minimal visual impact).

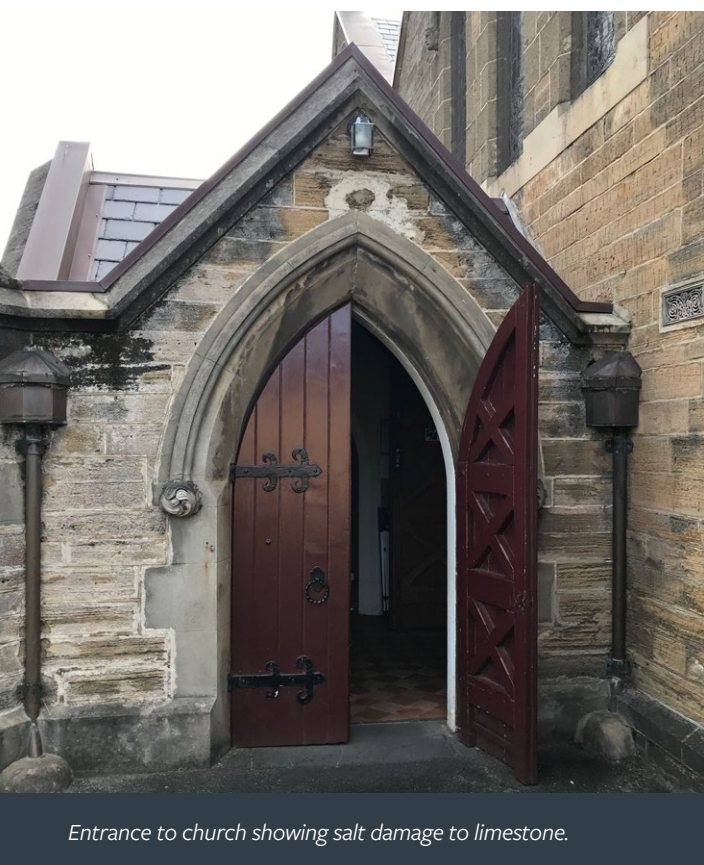
Climate change impacts will exacerbate conservation problems already experienced at the site. In particular, the soft limestone blocks and lime mortars used to construct the buildings are highly susceptible to salt penetration and weathering. The increasing intensity of storms will drive salt deeper into the walls and increase surface weathering, making conservation and maintenance even more difficult. Damage has already occurred to the church tower and walls, and deposits of salt on the inlaid tile work of the war memorial have had to be removed. Original paint schemes uncovered by recent conservation works will be threatened by an increase in levels of salinity and moisture.

Entrance to church showing salt damage to limestone.

The parish council is working with a consultant with expertise in materials conservation to mitigate the deterioration of the fabric. The proposed works include removing asbestos panelling and layers of acrylic and lead-based paint from porous stone surfaces to ensure breathability and

allow the moisture content of the stone to be monitored. These conservation works are addressing the weathering and decaying of materials already caused by the slow accumulation of salt over time, but will help mitigate the acceleration of this problem that is expected under climate change.

In addition to existing conservation works, the addition of limewash or a similar porous substance is to be trialled to establish the rate of salt deposition.

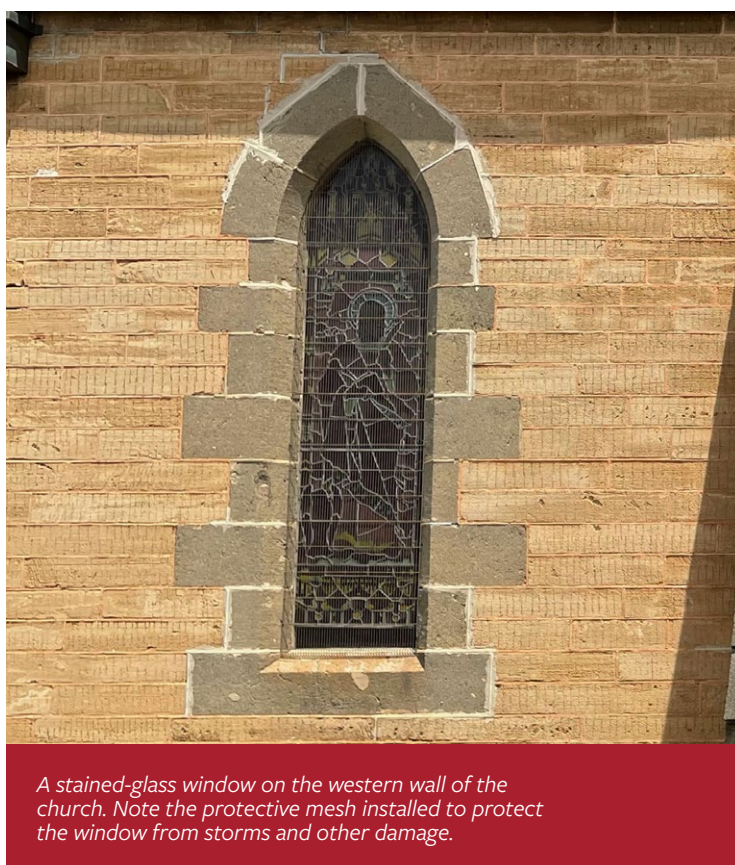
Stained-glass windows facing north and west are particularly vulnerable to hailstorms, which are expected to be more frequent and severe.

A stained-glass window on the western wall of the church. Note the protective mesh installed to protect the window from storms and other damage.

Other considerations for climate resilience at the site include installing discreet protection for stained-glass windows, reassessing roof and stormwater drainage capacity in the light of increased intensity of rainfall and storms, and developing water resilience strategies to safeguard plants and gardens.
