## CASE STUDY

# Bank at Vaughan

The Bank at Vaughan project has restored and extended a dilapidated former bank building in the Victorian goldfields. The new interiors evoke earlier finishes, while the new amenities ‘pod’ reflects and reinterprets the form of the bank building. The process of reviving the heritage building and converting it into a home and studio has drawn attention to the quality and value of other historic buildings in the village.

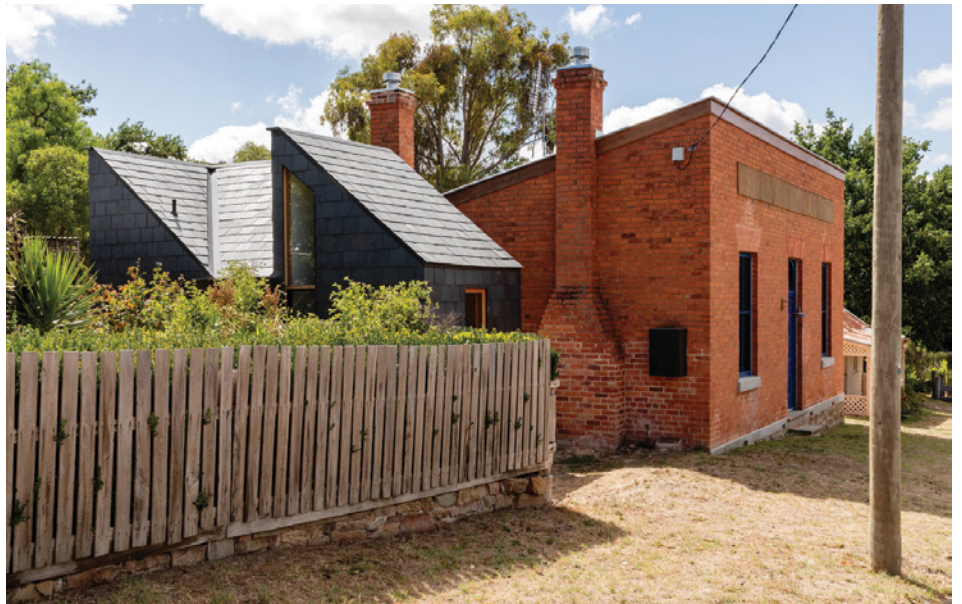
**Top** Street view: the counterposed angled roof and robust materials of the new amenities pod respond to the character of the heritage building. **Bottom** The Bank at Vaughan was derelict prior to the new work to convert it into a home. (Photographs courtesy of Maria Danos Architecture).

The form of the amenities pod is a playful interpretation of the unusually steep skillion roof of the bank, with the slope reversed. The gravitas of the original brick, stone and timber has informed the material choices of the addition – the slate cladding has equivalent robustness and dignity. The interior is designed to be ‘light and uplifting’, an intentional counterpoint to the ‘moodiness and weight’ of the heritage building.

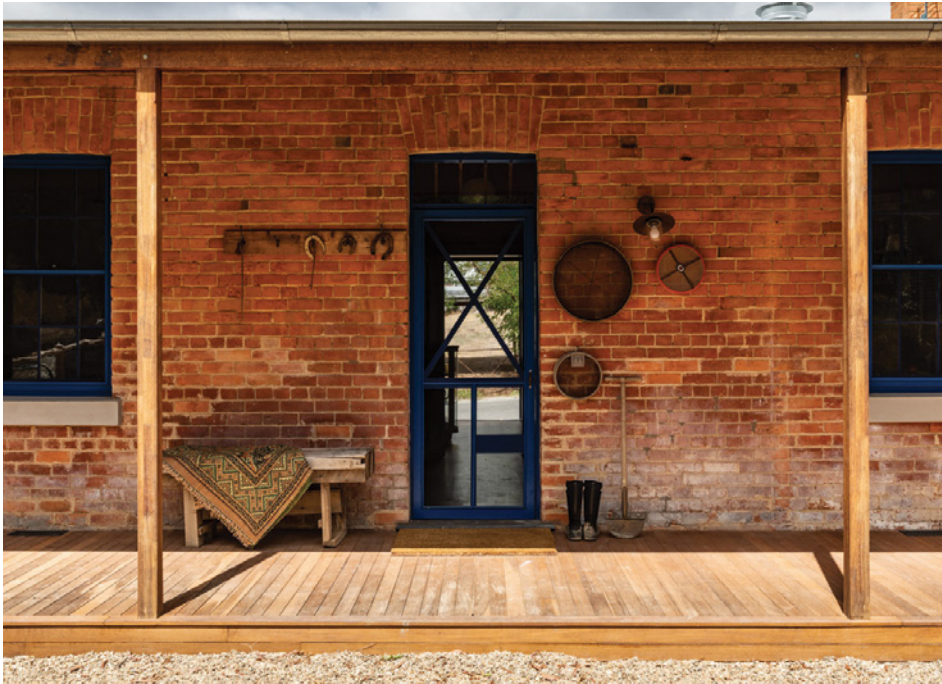
**Top** Rear verandah. **Left** Floorboards salvaged from the bank now line the amenities pod.

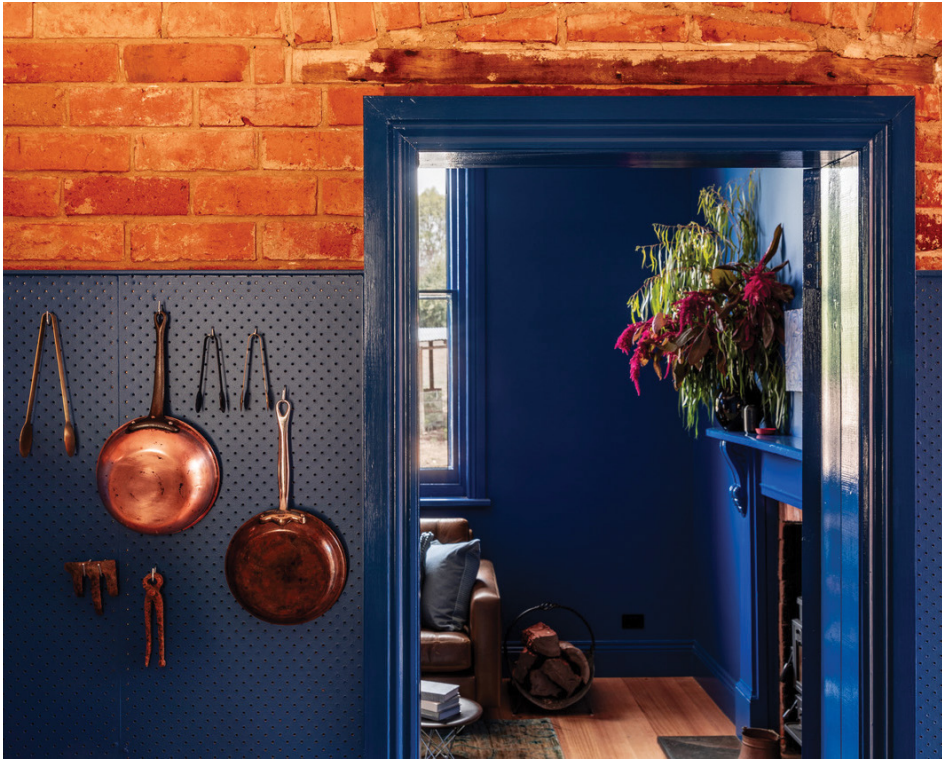
**Top and left** Views from and into the new kitchen. **Right** The extension is connected to the original by a glazed link, which provides visual separation between old and new.
