HERITAGE COUNCIL DETERMINATION

Determination Date	4 October 2018
Place/Object Name	Murchison Prisoner of War Camp
Location	410-510 Wet Lane, Murchison, Greater Shepparton City
VHR Number	H2388
Category	Heritage Place

Recommendation of the Executive Director and assessment of cultural heritage significance under Division 3 of the *Heritage Act 2017*

Name	Murchison Prisoner of War Camp (Camp No.13)
Location	410-510 Wet Lane, Murchison, City of Greater Shepparton
Provisional VHR Number	PROV VHR2388
Provisional VHR Categories	Heritage Place, Archaeological Place
Hermes Number	5592
Heritage Overlay	Greater Shepparton, HO57 (individual)

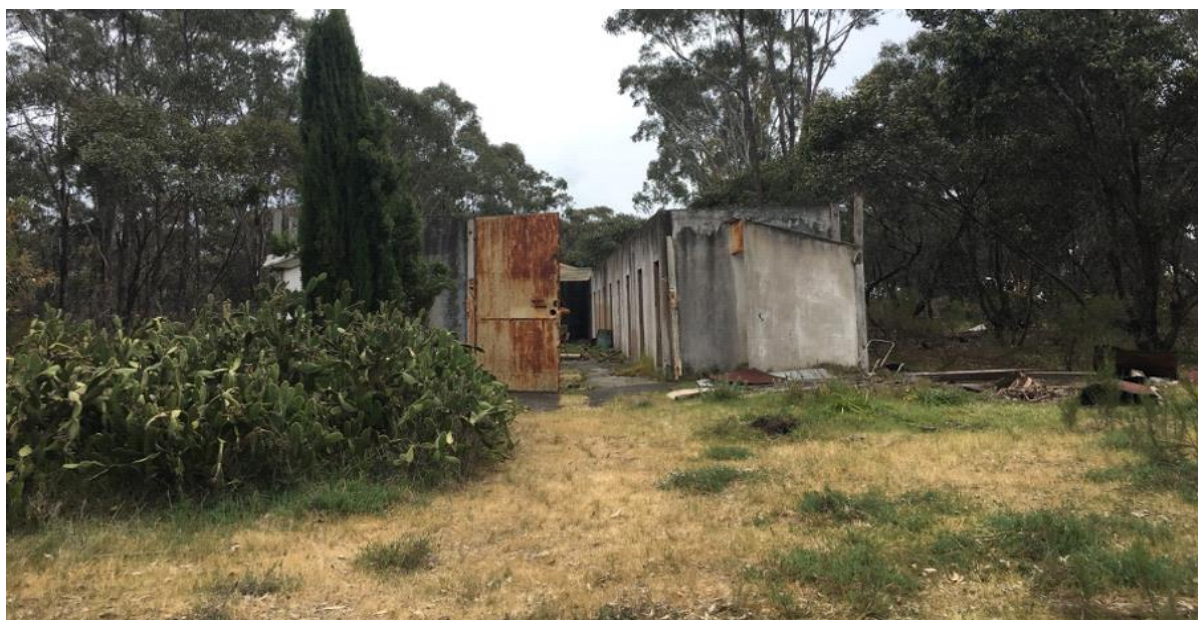
Murchison Prisoner of War Camp, Southern Cell Block, October 2017

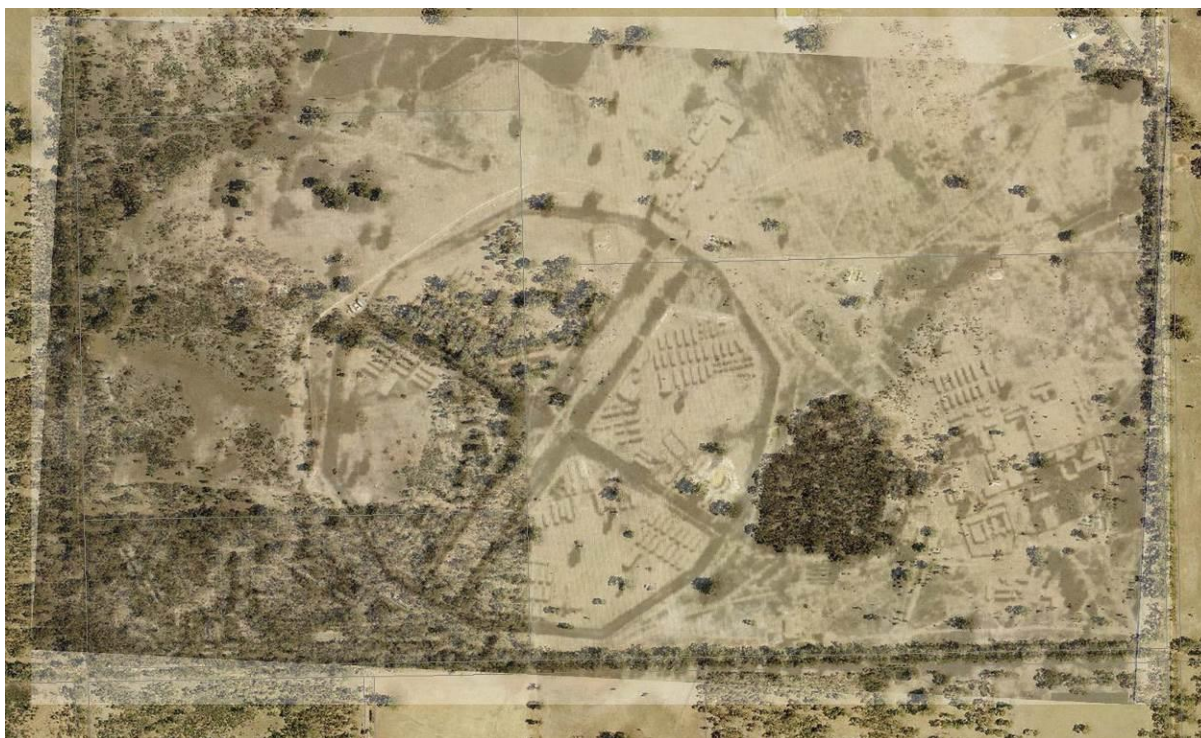
1949 aerial overlaid on modern aerial photograph

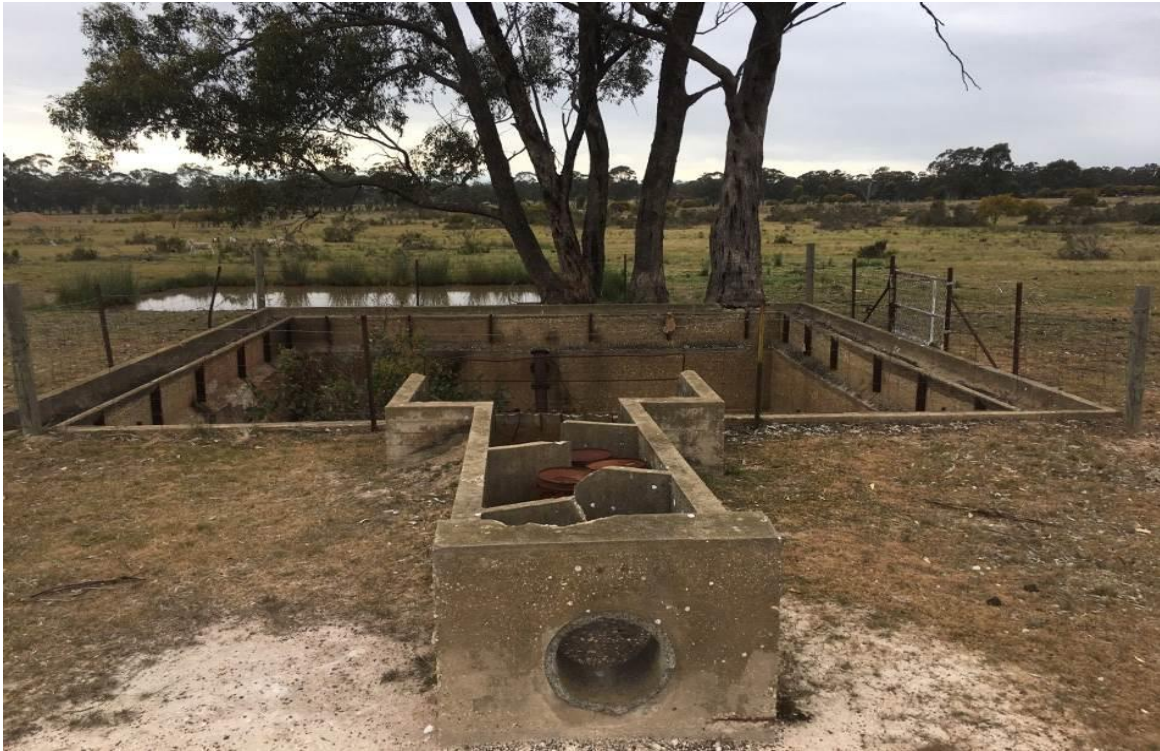
Water treatment plant, F.4

- F4. Near Compound C: water treatment plant comprising concrete ponds and machine foundations
- F5. Adjacent to northern end of compounds B & C: northern cell block, concrete with two rows of ten cells

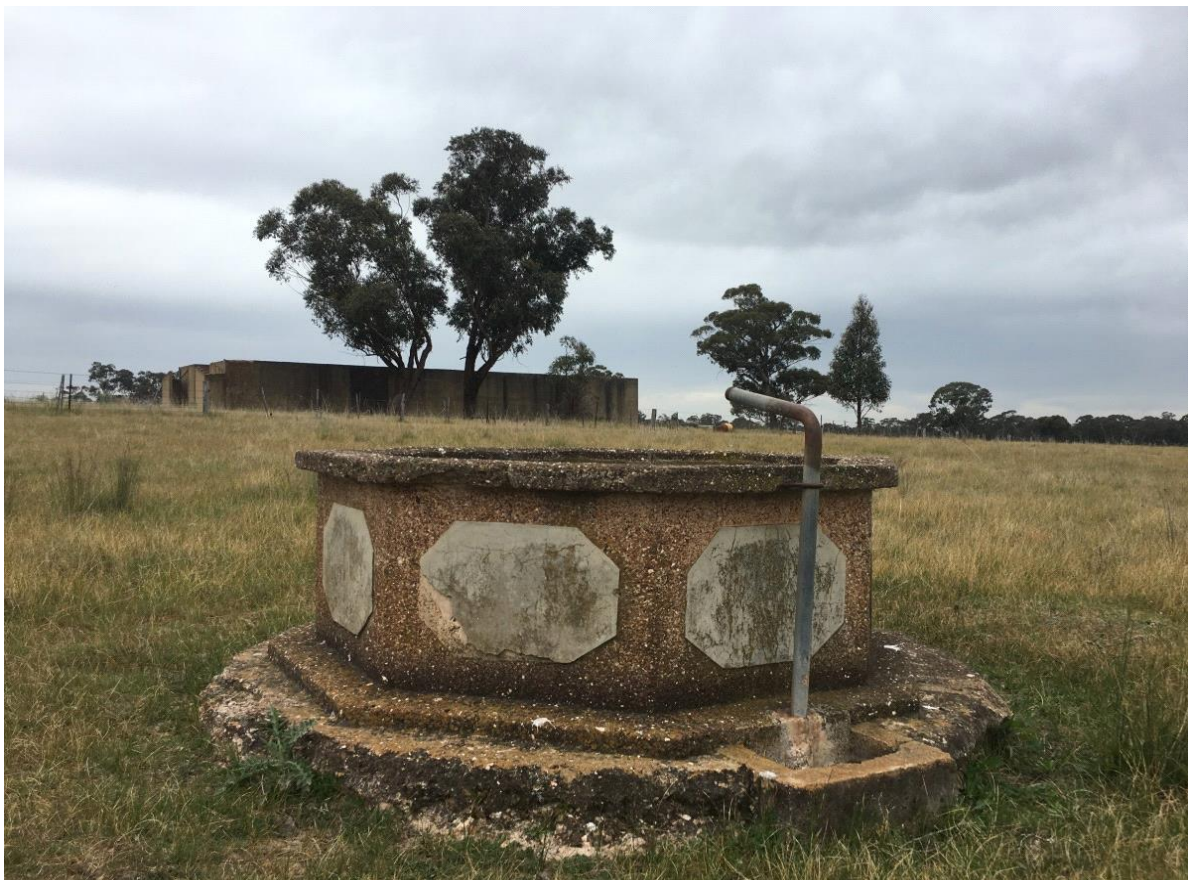
Ornamental Pond and northern goal, F.6 & F.5

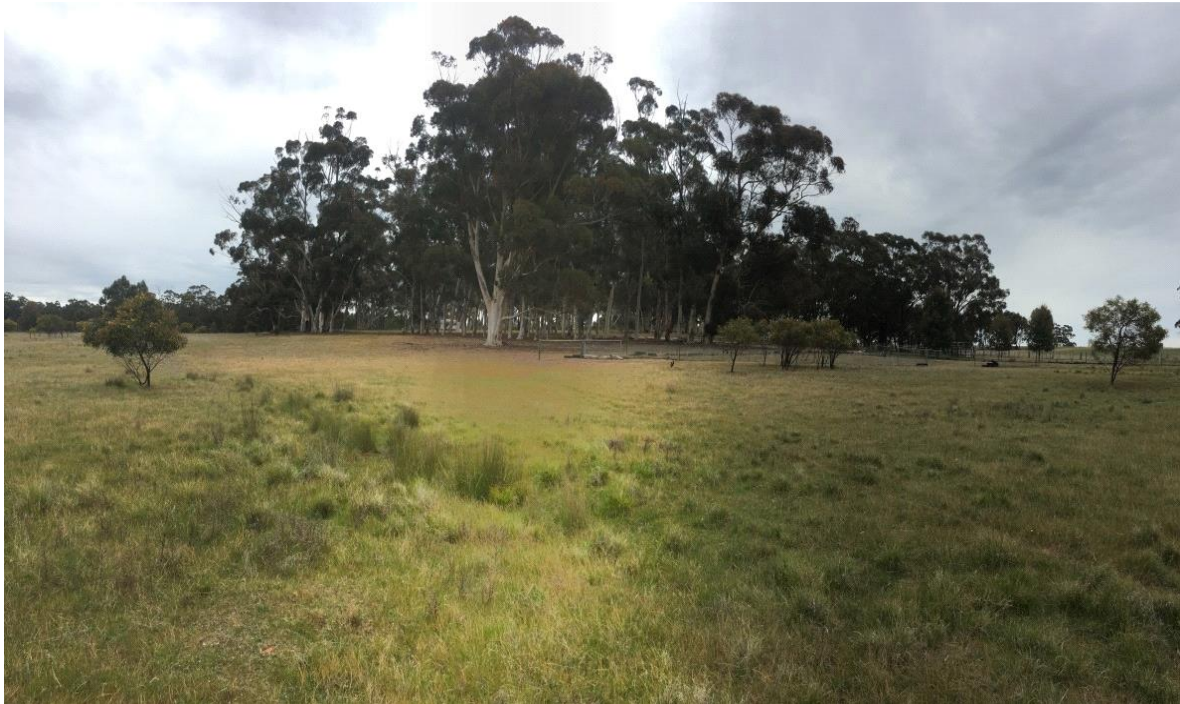
Sugar gums planted by prisoners, F.7 (2017)

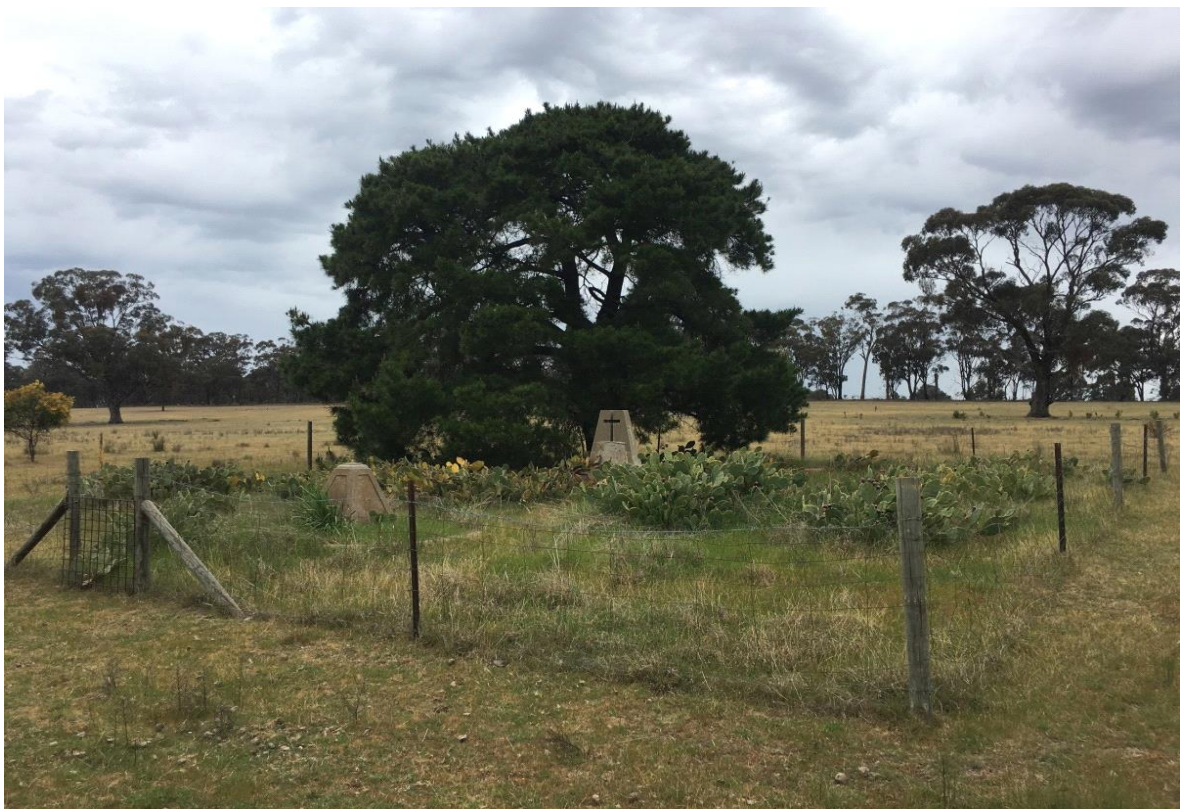
Italian memorial, F.19 (2017)

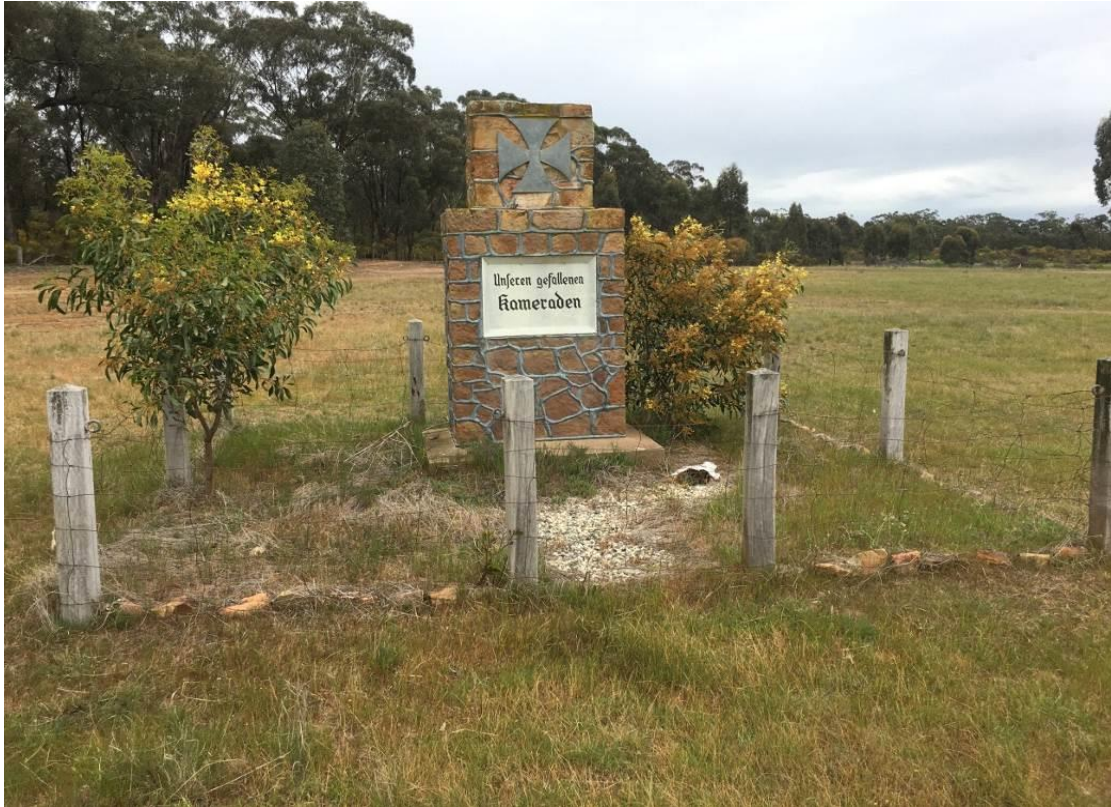
Kormoran memorial, F.11 (2017)

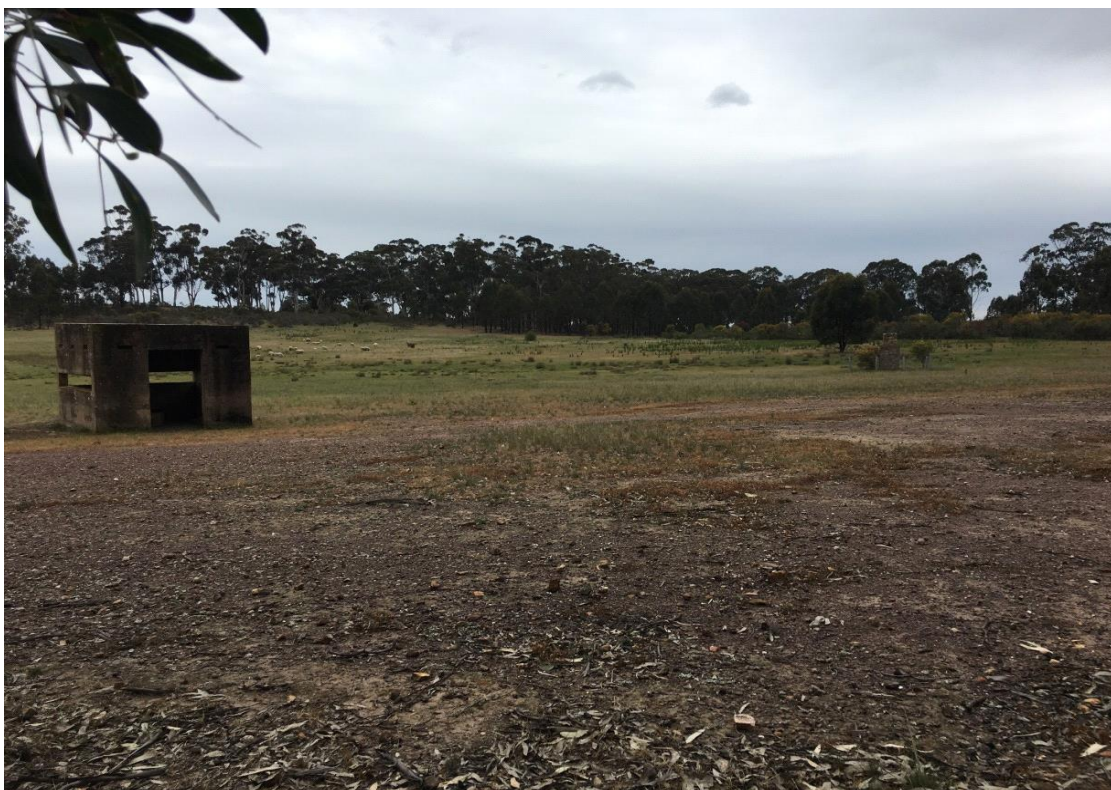
Machine gun emplacement, F.12 (2017)

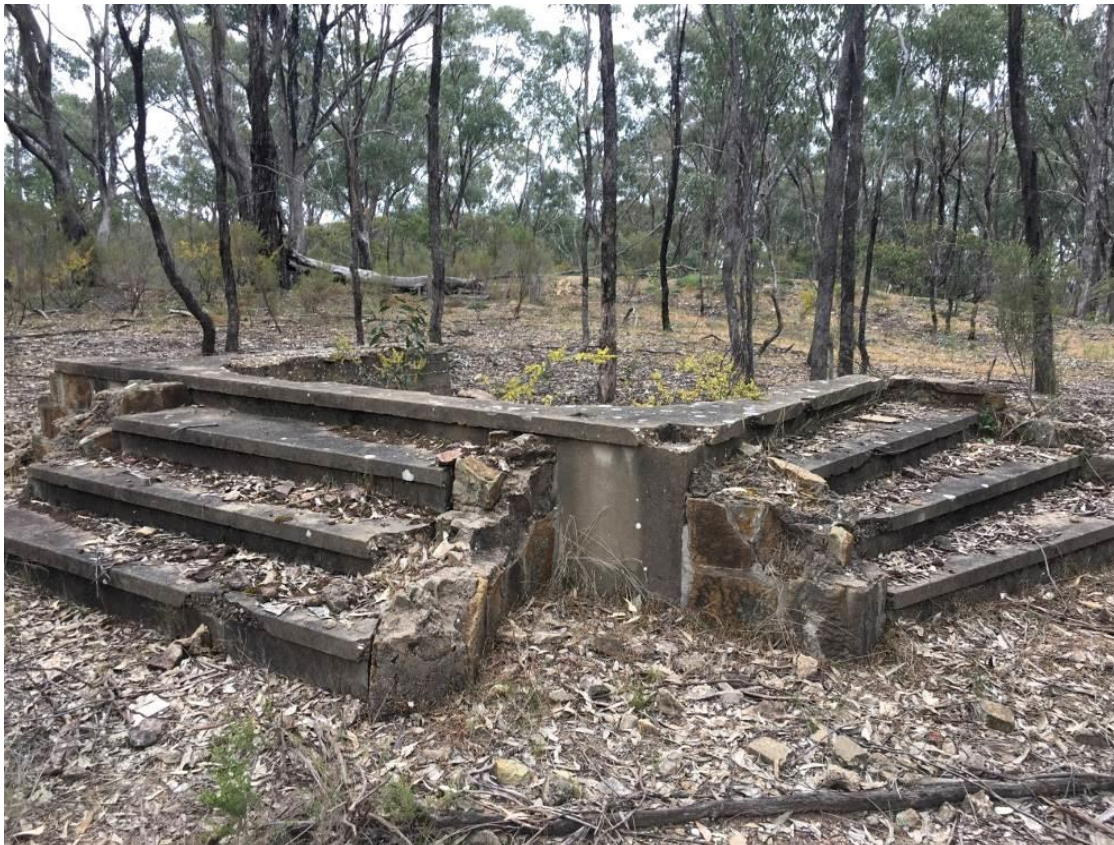
Steps, Guards' Quarters, F.13 (2017)

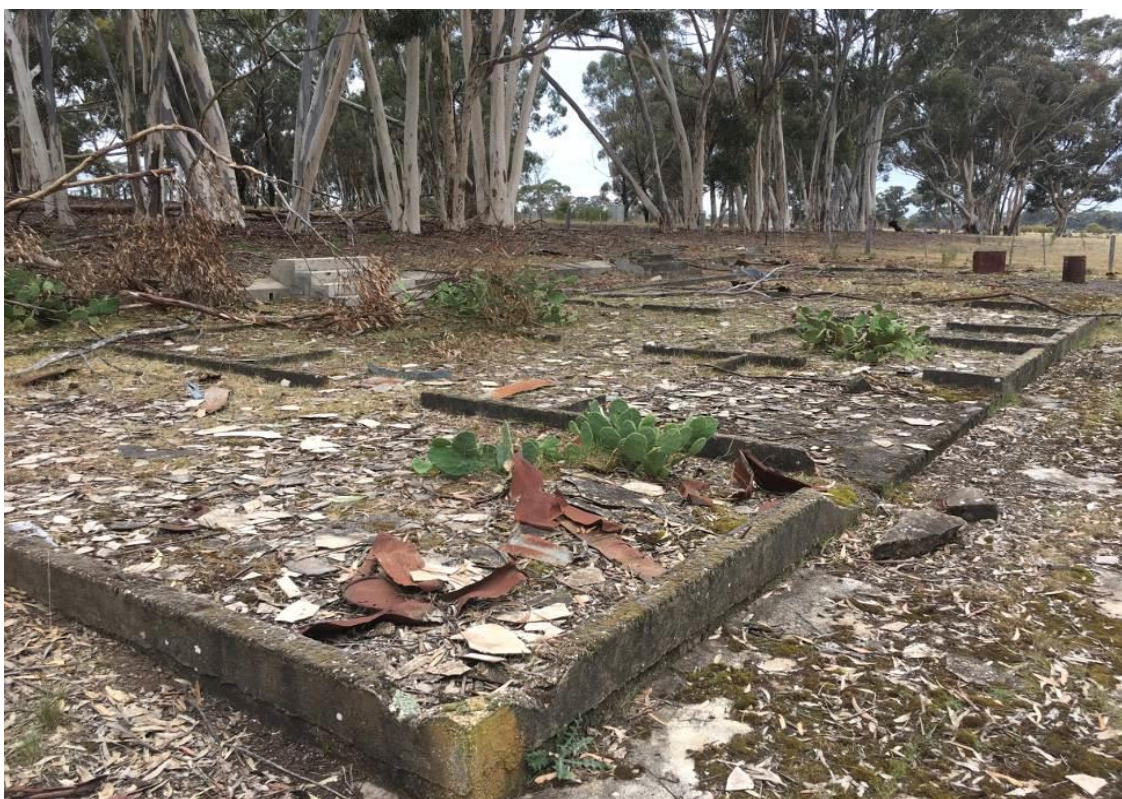
Concrete floor slabs, F8 (2017)

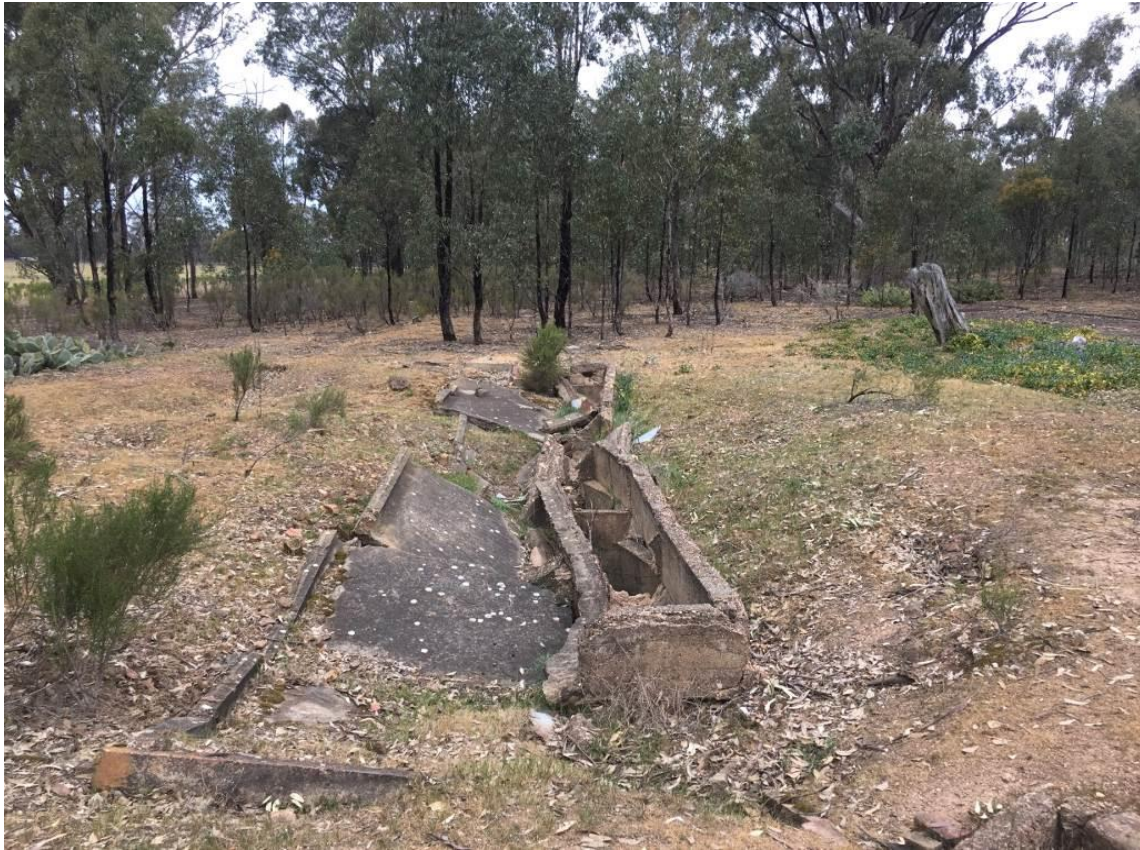
Collapsed latrine pits, F.8 (2017)

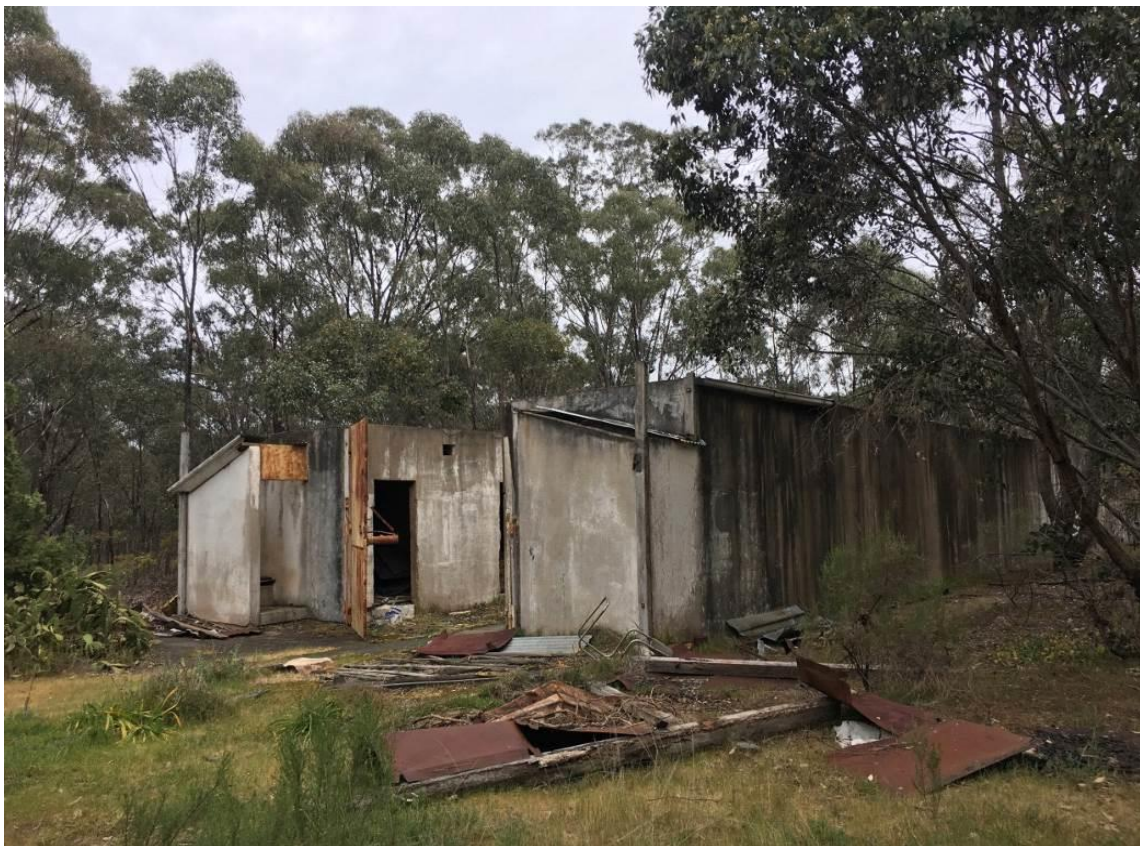
Southern Goal, F.17 (2017)

- F16. Guards Quarters: large dam and tramway
- F17. Guards Quarters: southern cell block, concrete with two rows of ten cells, with solid iron gate
- F18. Compound D: traces of concrete foundations

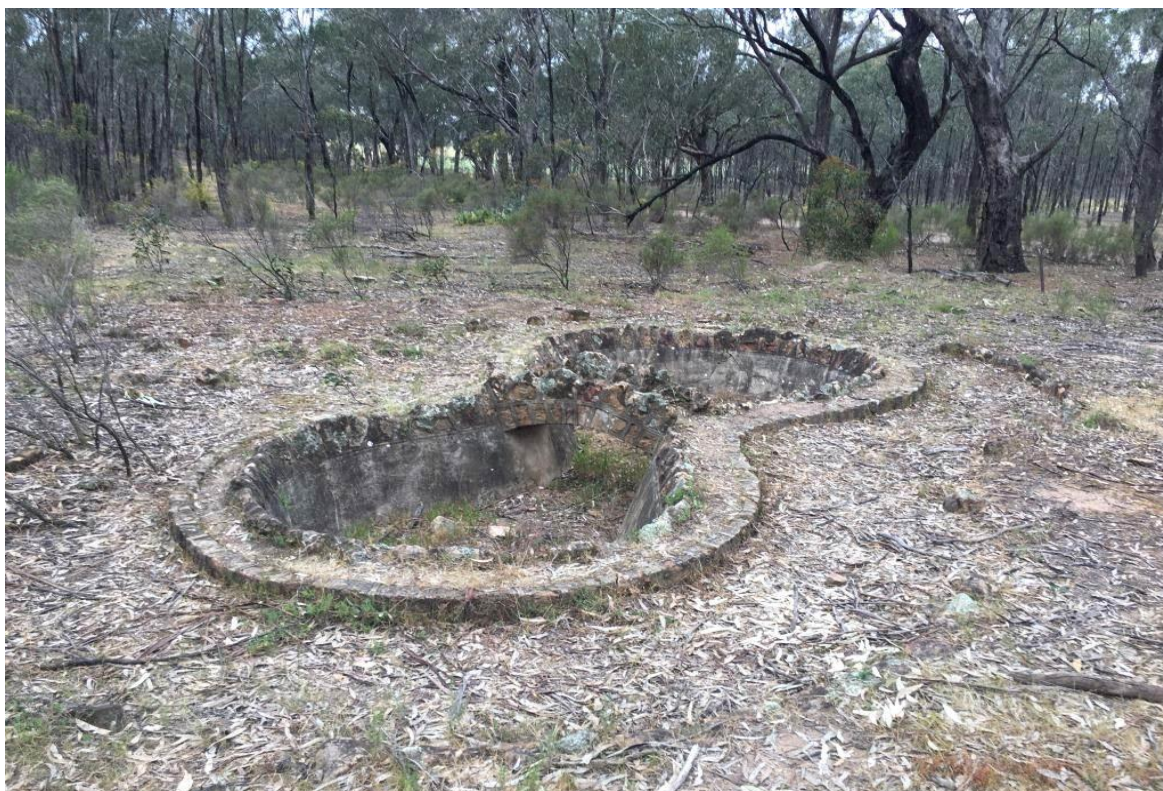
Figure eight pond, F.15 (2017)

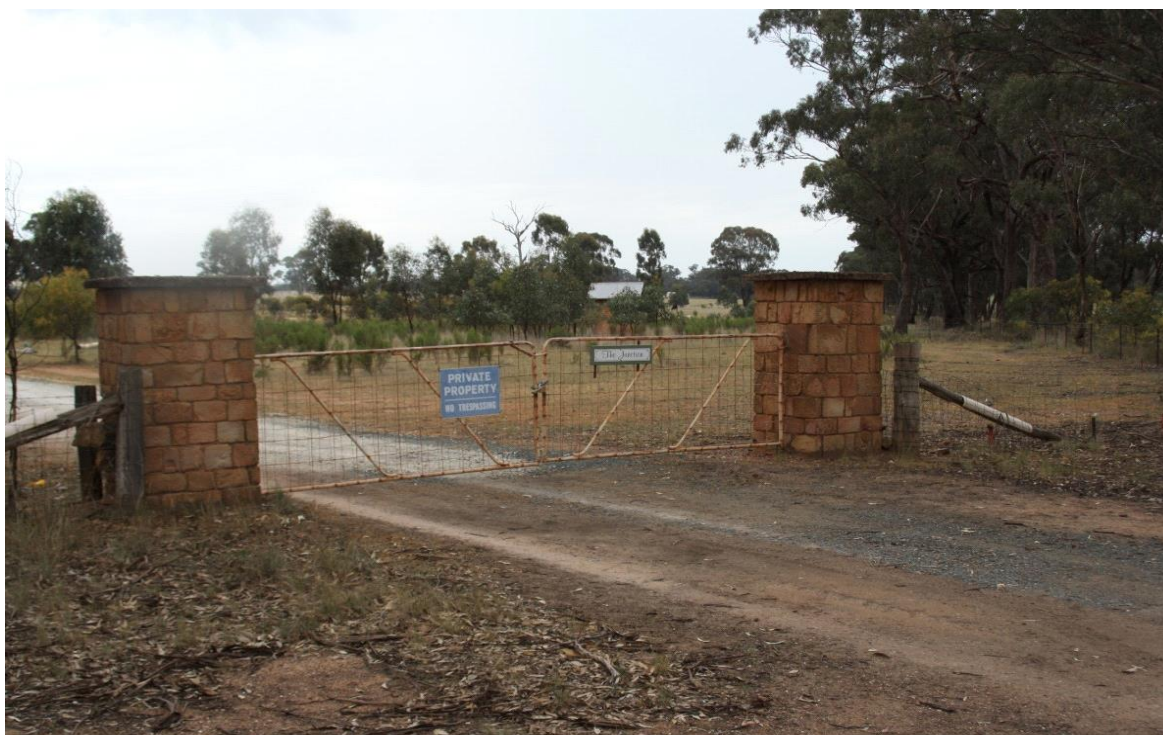
Gateway piers, F.1 (2017)

The interior of the stone sentry box (F2) contains some graffiti, in the form of dates and some initials. There also appears to be an initial engraved on one of the stone gateway piers (F1). The interior of one of the cells in the southern cell block (F17) may still retain the following graffiti recorded by a visiting former POW. Wandering through the Camp, an ex-POW found written on the wall of one of the cells in German the words 'Humor ist wegn man trotsdem lacht' – Humour is when one laughs in spite of it all.

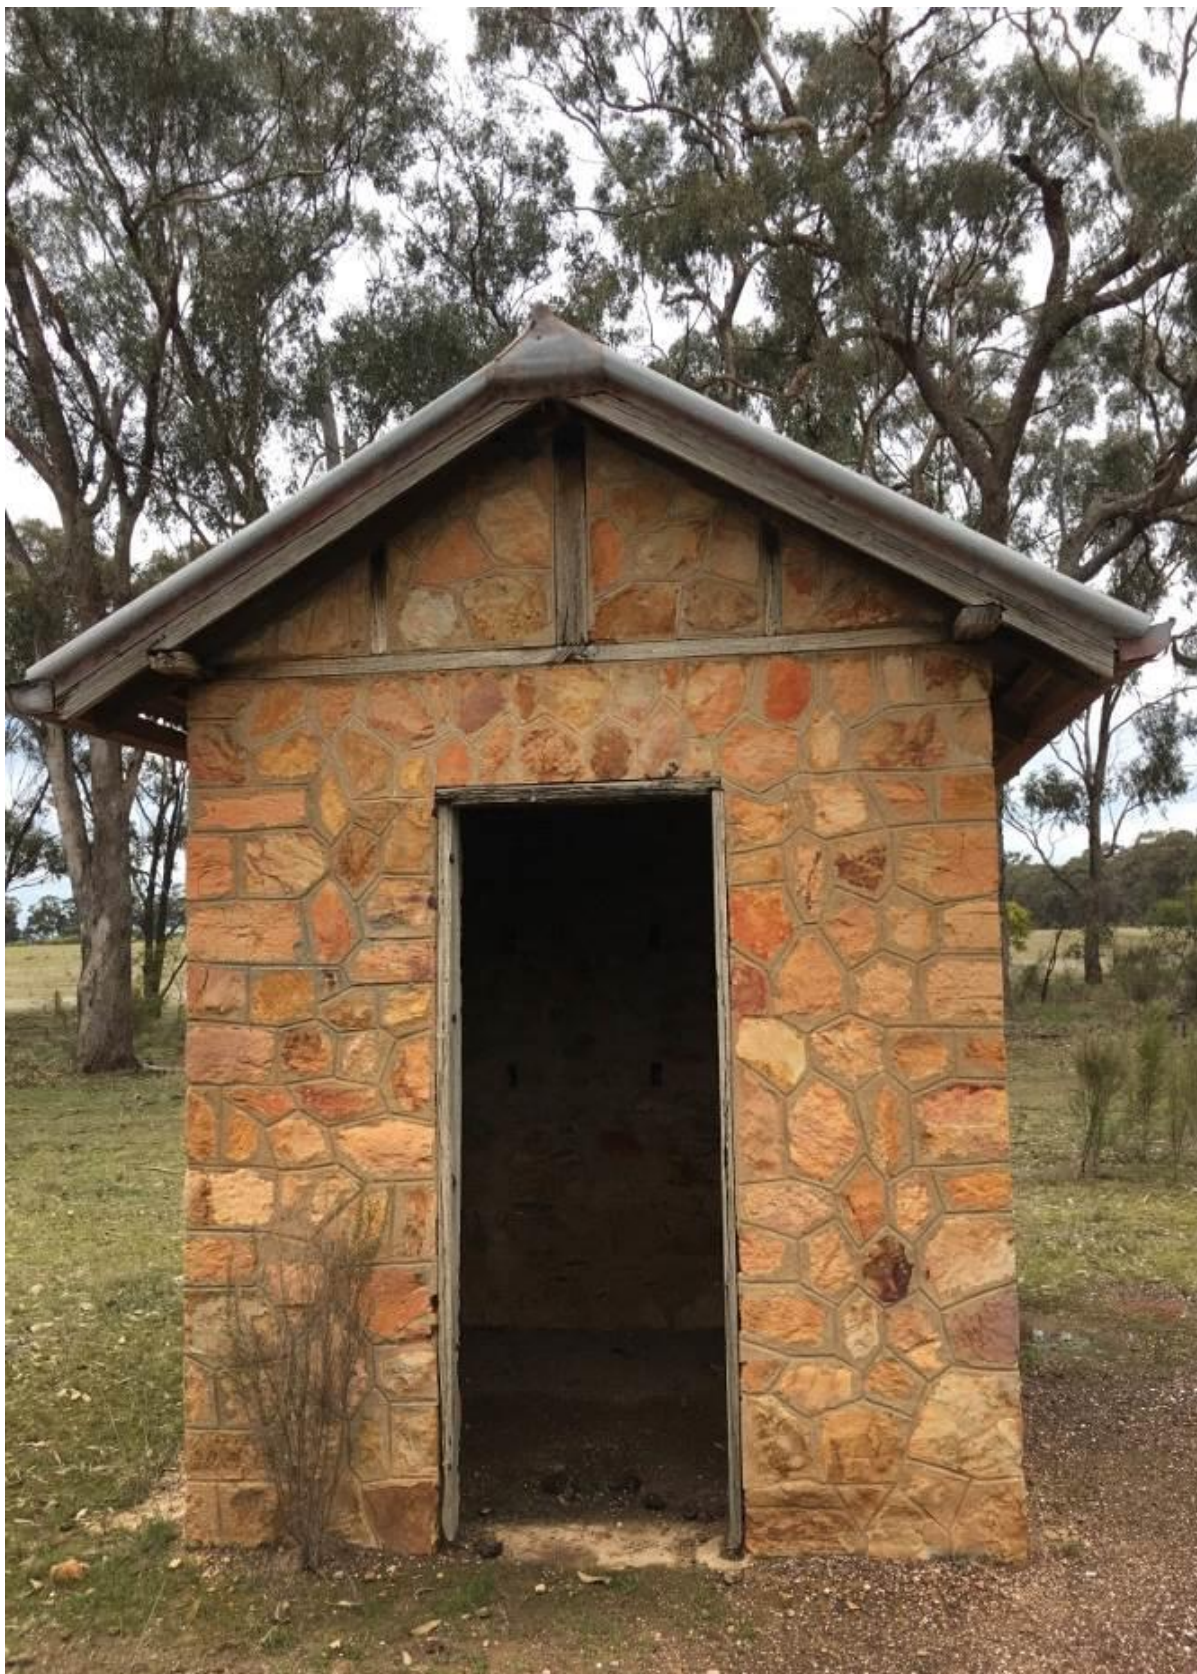
Sentry box, F.2 (2017)

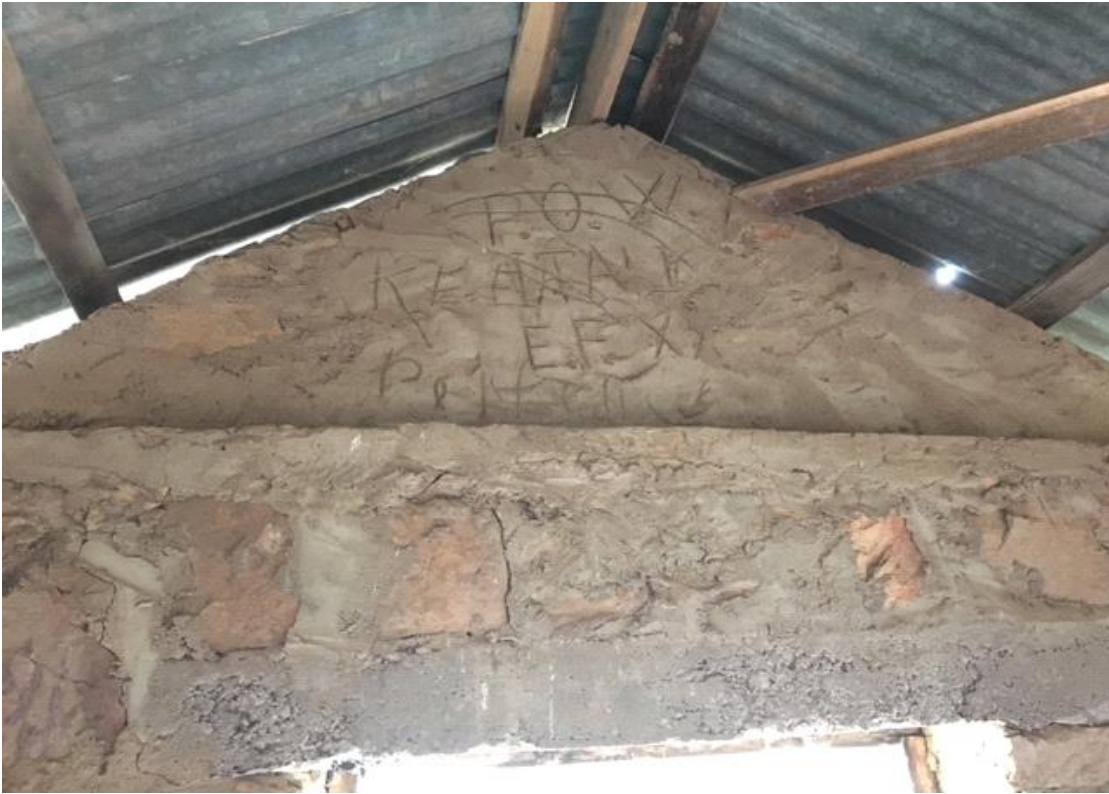
Graffiti, sentry box, F.2 (2017)
