Mooramong Homestead

Site vulnerability and heritage impacts

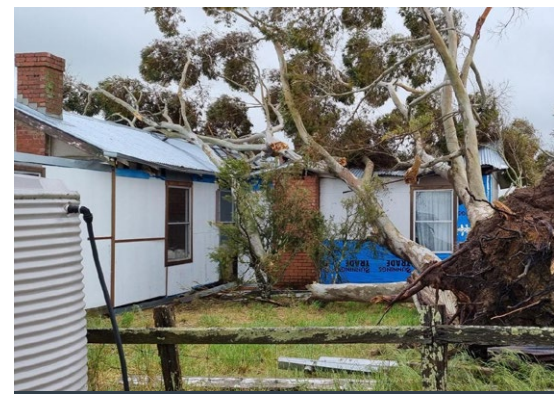
Roof damage to an outbuilding from a severe storm. More frequent severe weather events will result in a greater likelihood of tree falls.

- ensuring that the asset protection zone is maintained for protection against wildfires
- installing ember mesh to prevent embers entering the subfloor and roof spaces
- installing roof sprinklers on the most important buildings
- installing disaster bins to store and transport the collection in an emergency
- insulating the roof space to reduce the heat load inside the house
- fitting seals around door and window frames to reduce heat loss in winter and reduce the risk of ember attack and smoke damage during fires
- opening the house up to enable it to dry after long rain periods
- installing an internal climate control system and data logger to monitor damp
- regular inspections to monitor the condition of the house, outbuildings, garden and collections.

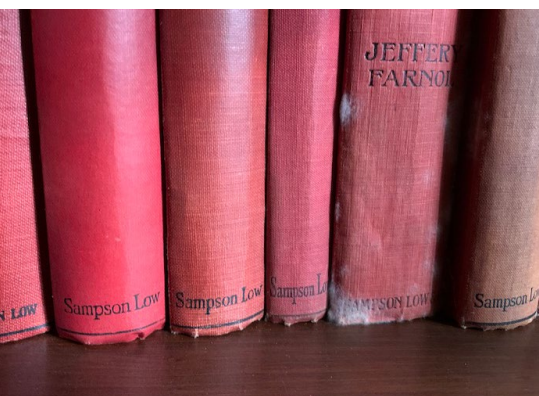
Higher internal humidity has been experienced in the house due to rising dampness from the slab following heavy rainfall. This increases the risk of mould and fungal growth and insect attack on the building fabric. Mould could also damage furniture, artwork, clothes, jewellery, tableware, books, photographs and curios, and affect the health of employees and visitors.

Deterioration or damage to internal collections.

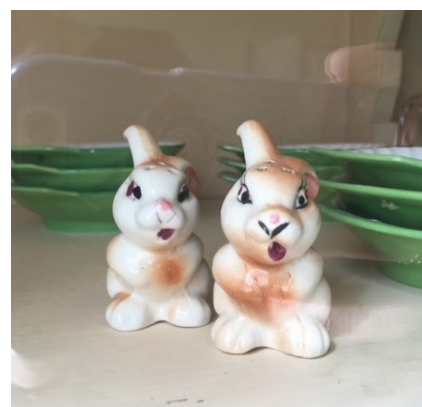
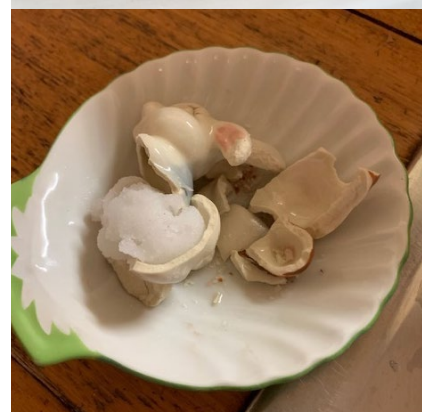
Example of a damaged object: increased humidity caused the salt to expand and crack a rabbit salt shaker.
